Manhole Inspection Summary

Manhole # S25OO1001MH

Insp Date: **11/6/06 11:57 AM**

Location Address: **300 GOODWOOD GARDEN**

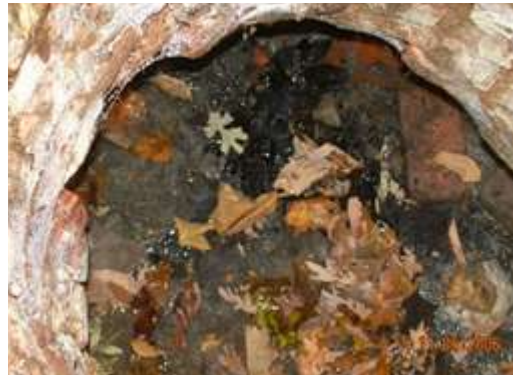
Top View

Adjustment deterioration. Bench and Channel debris.

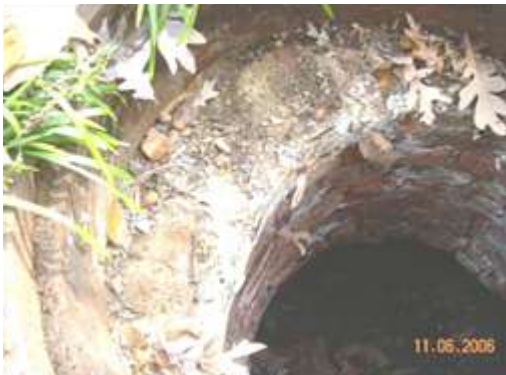
Defect

Frame leaks. Frame offset. Adjustment deterioration and infiltration.

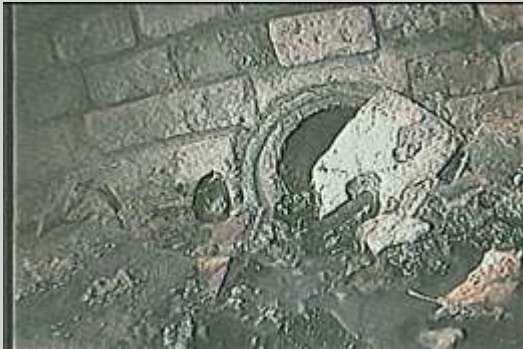
8 in. Circular Gravity Sewer Pipe Out @ 12 O'Clock

Deposits: ☐ None ☐ **Mud** ☐ Sludge ☒ **Debris** ☐ Grease

Silt Depth: **3** (in.) Deposits Extent: **Medium**

Infiltration: **Evidence** Pipe Seal Cond: **Unknown**

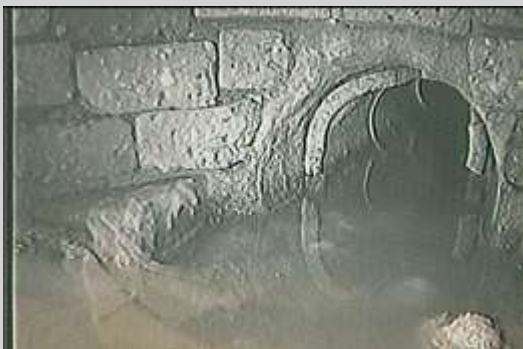
8 in. Circular Gravity Sewer Pipe In @ 4 O'Clock

Barrel deterioration and infiltration.

Deposits: ☐ None ☒ **Mud** ☐ Sludge ☒ **Debris** ☐ Grease

Infiltration: **None** Pipe Seal Cond: **Broken**

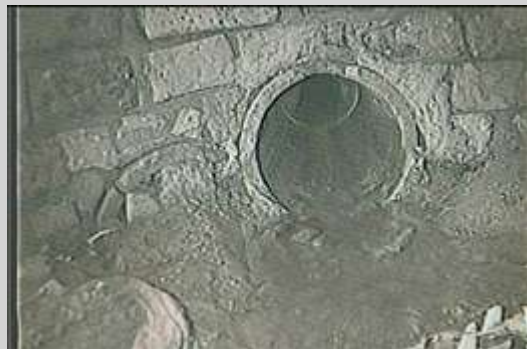
Pipe In @ 8 O'Clock

Deposits: ☐ None ☒ **Mud** ☐ Sludge ☒ **Debris** ☐ Grease

Infiltration: **Evidence**

Pipe Seal Cond: **Broken**
